**RESTORATION OF FLATS IN LA-PLAZE
APARTMENTS, HAZRATGANJ**

ORIENTAL INSURANCE CO. LTD

**Prepared by
Ar. Deepak Dhiran**

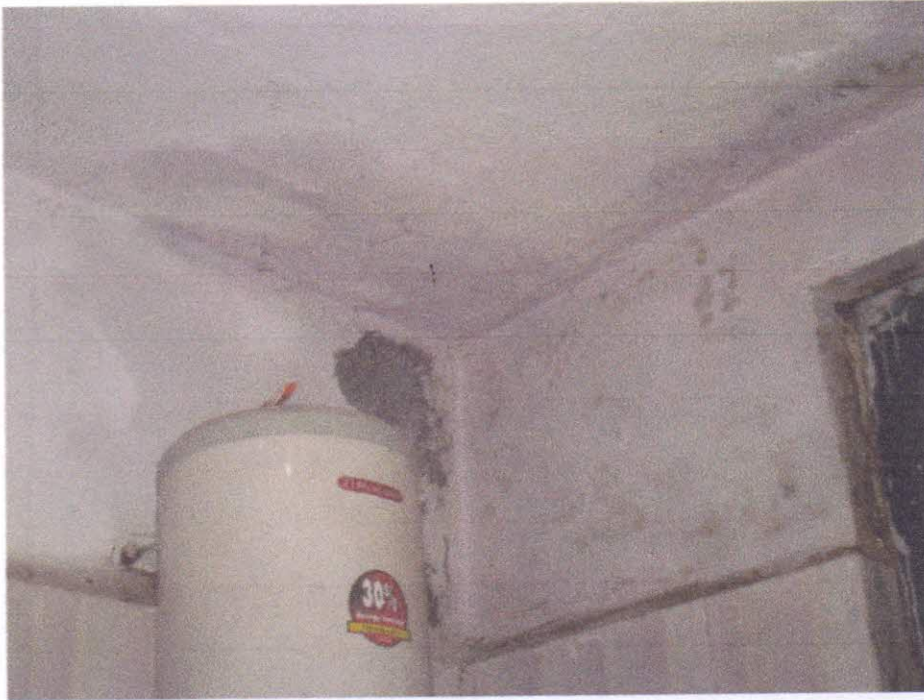
3.

Damp patches
in the bathroom
wall.

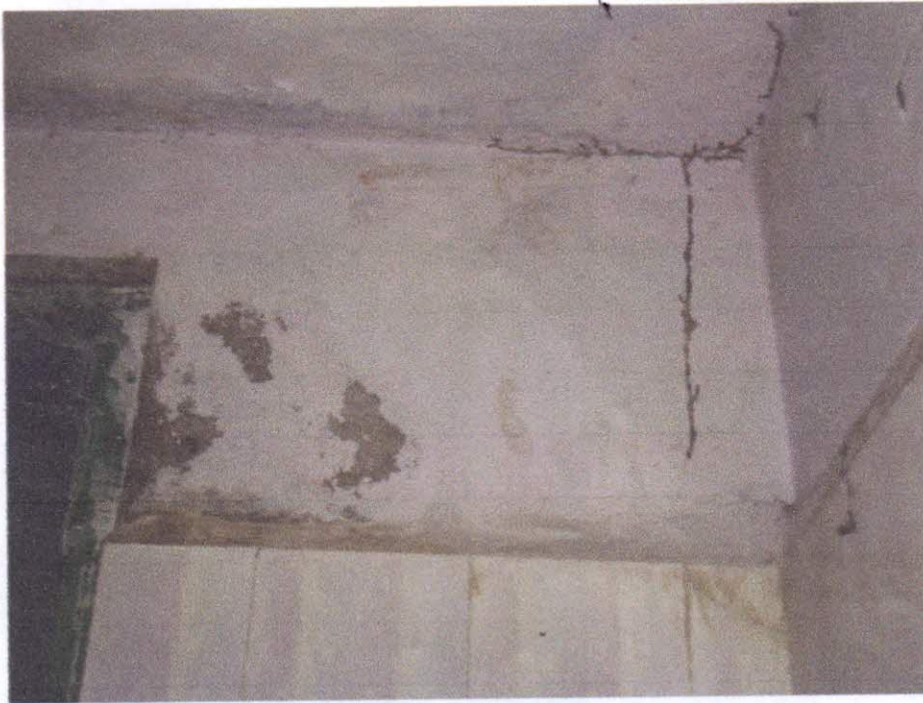
4.

Moist surfaces
and chipping
off plaster in
the toilet.

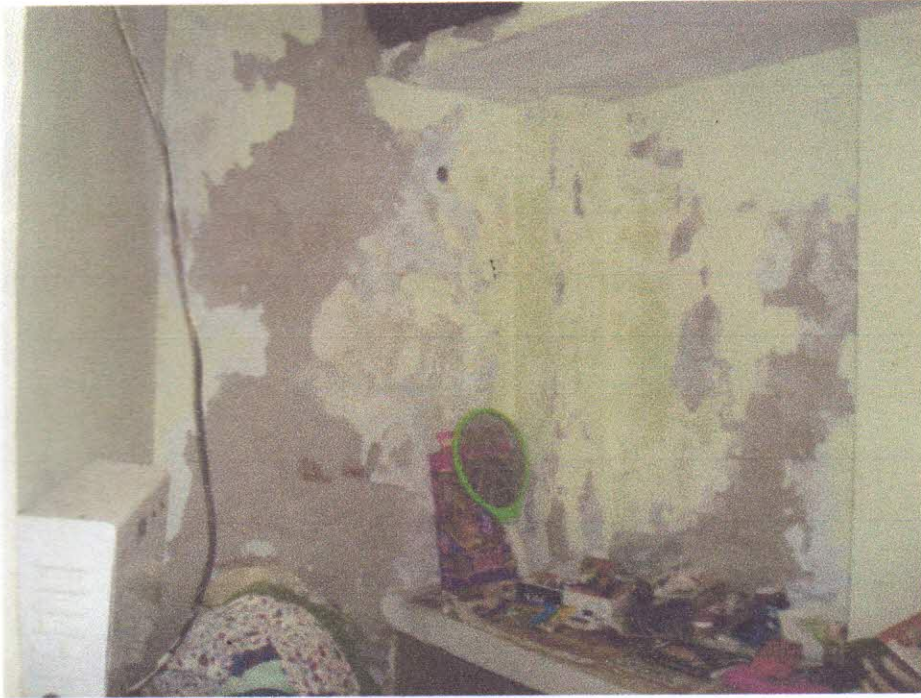
5

Utter loss of plaster near the shelf of the inner bedroom due to the moist conditions in the wall surface.

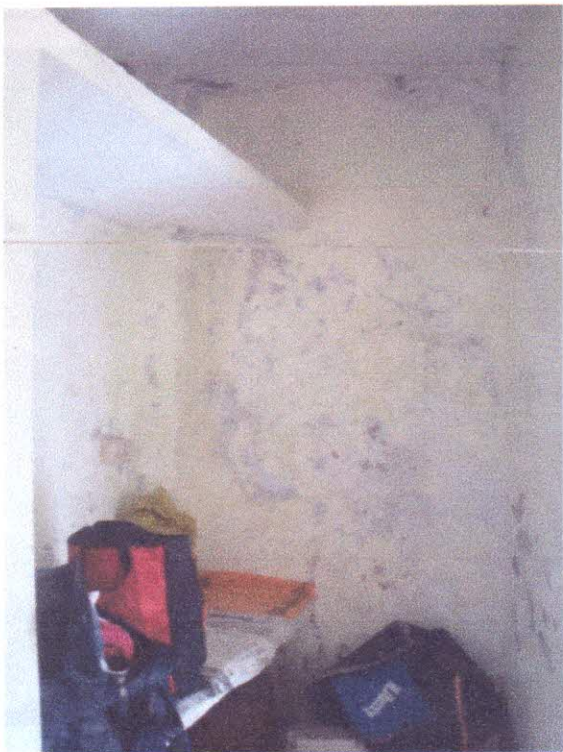
6

Stains and patches in the other bedroom near the shelf area.

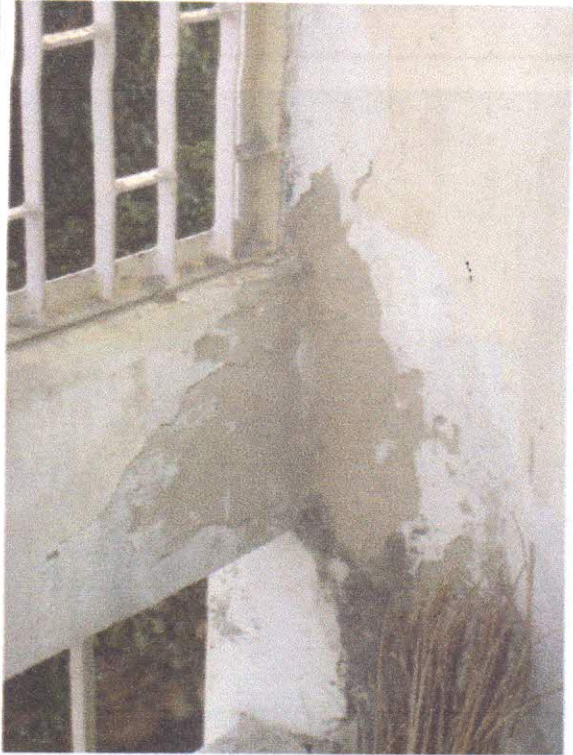
7

Plaster chipping off in the balcony of the flat caused by similar problems.

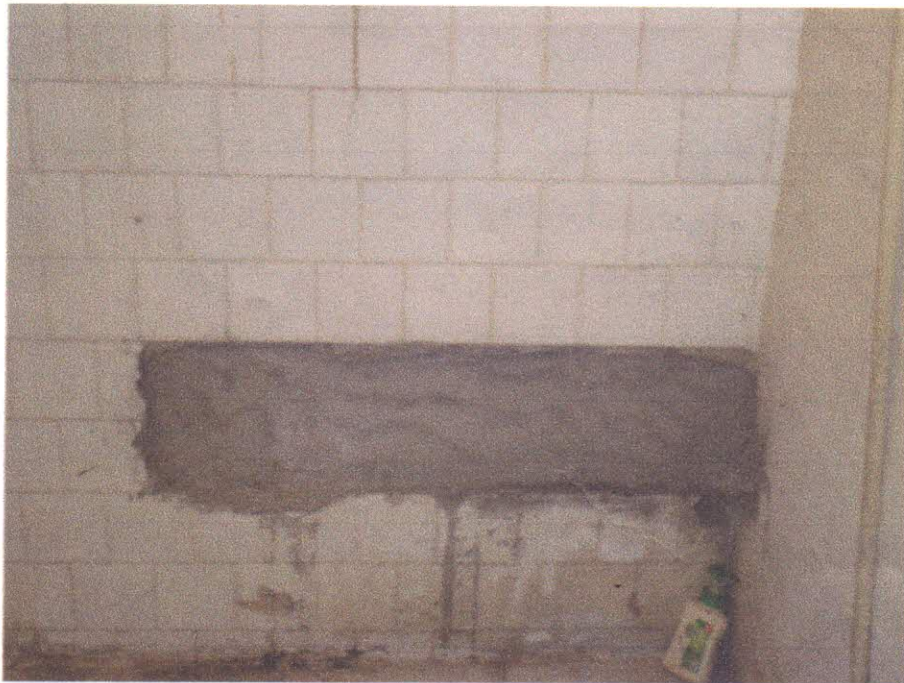
8

Wall tiles are missing in the bathroom. Need to be installed.

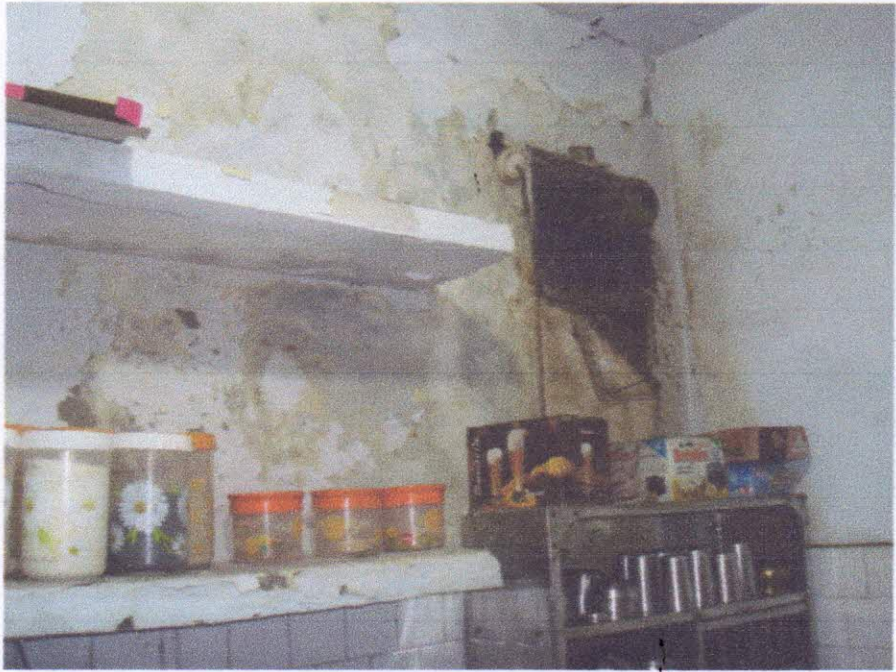
<p>Stains and patches caused by the dampness in the walls. Wall finishes have to be worked upon.</p>
2

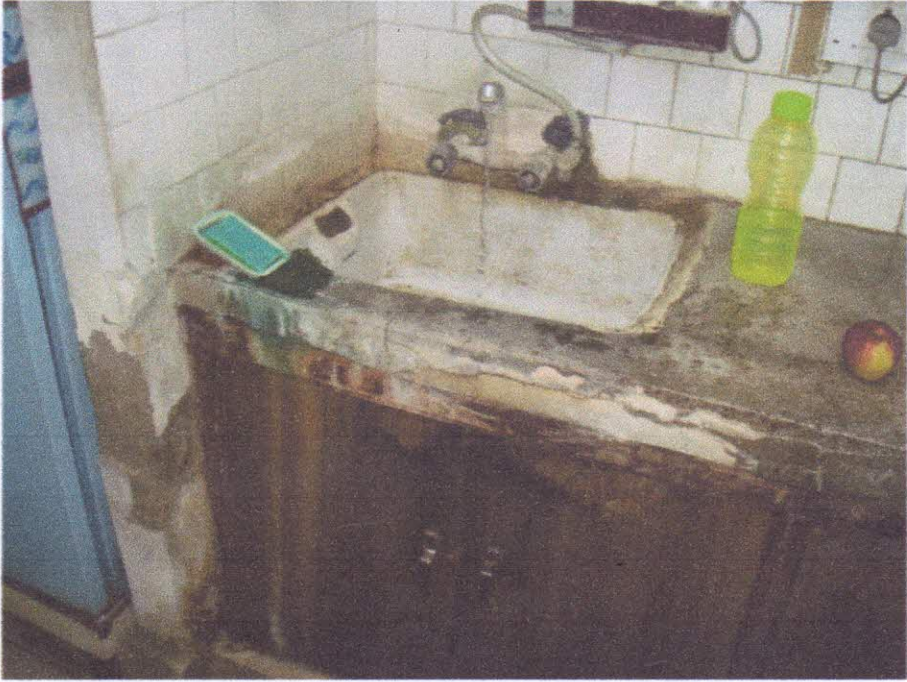
<p>Cracked and broken surfaces of the kitchen slab need to be repaired.</p>

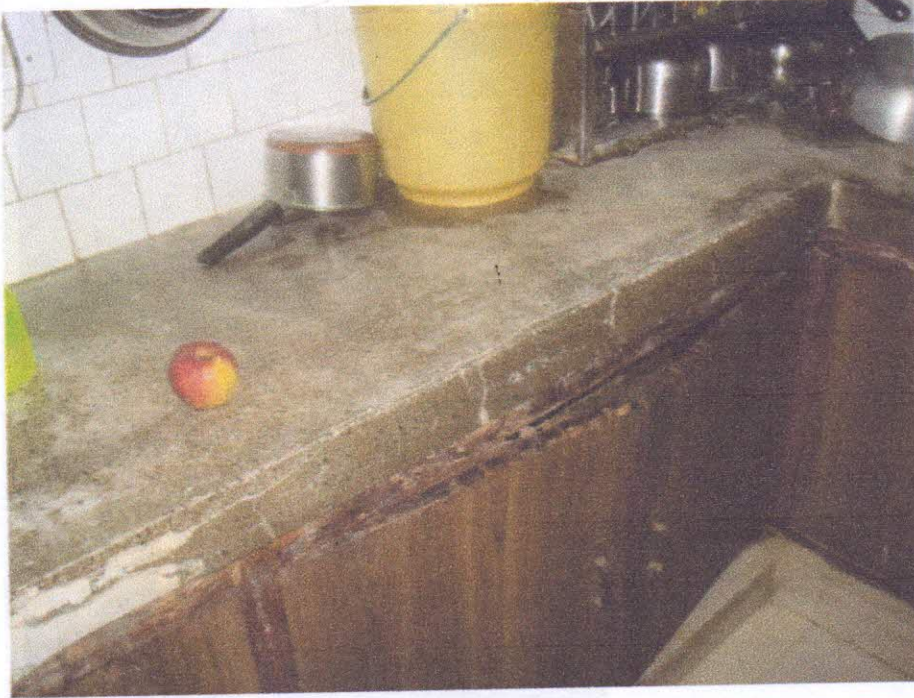
3

The wood work done in the kitchen is decaying and needs to be reworked.

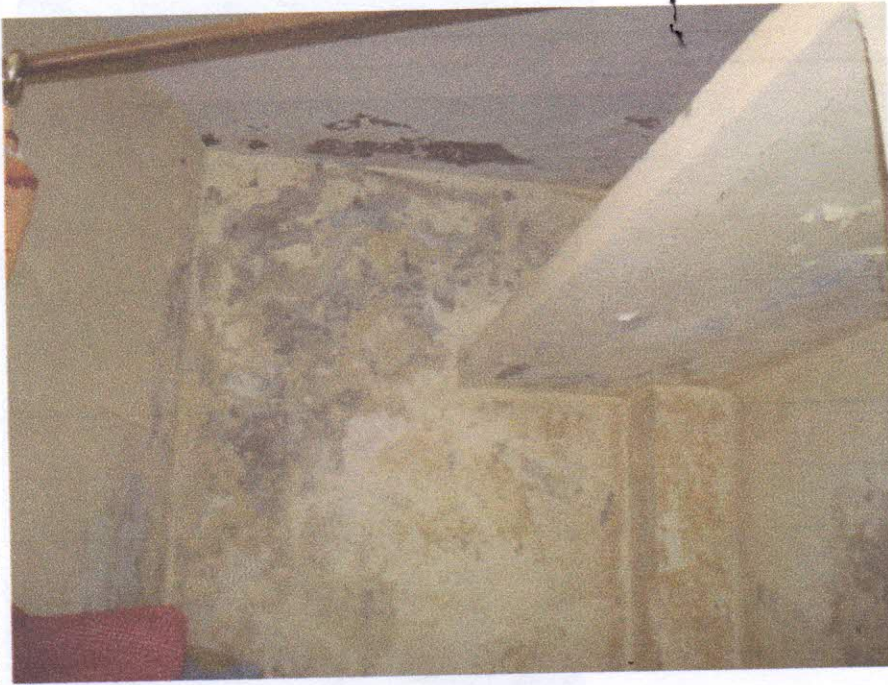
4

Stains are caused by the seepage in the wall causing loss of wall finish and plaster. The most vulnerable parts are those closer to the exposed surface of the flat on the rear, i.e. near the balcony.

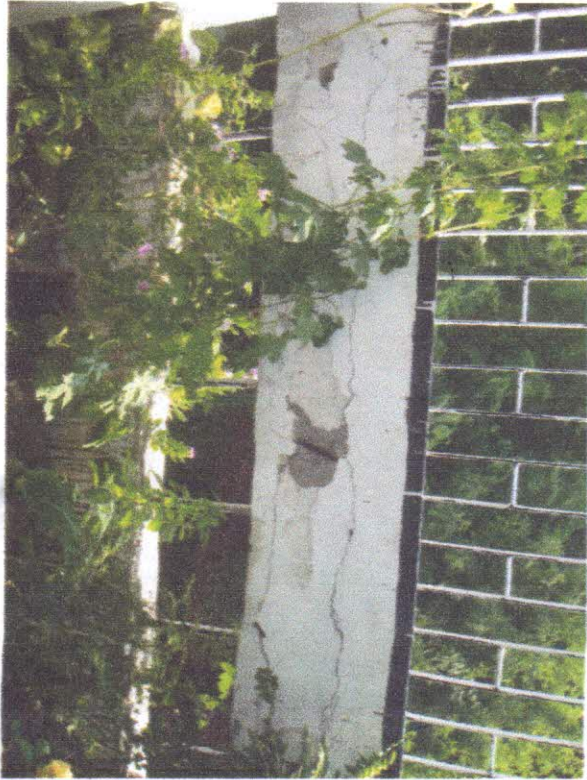
5

Cracked plaster
in the balcony
wall of the flat.

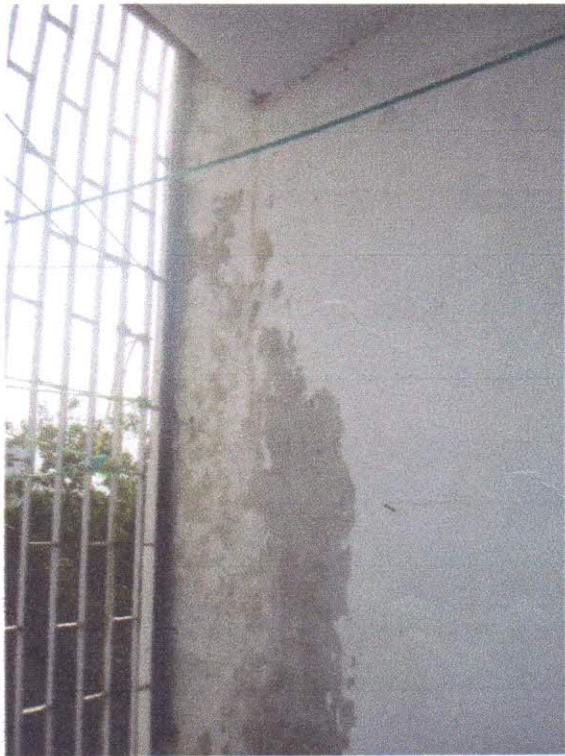
6

Stained wall
surfaces caused
by the same
reason, i.e.
seepage in the
wall.

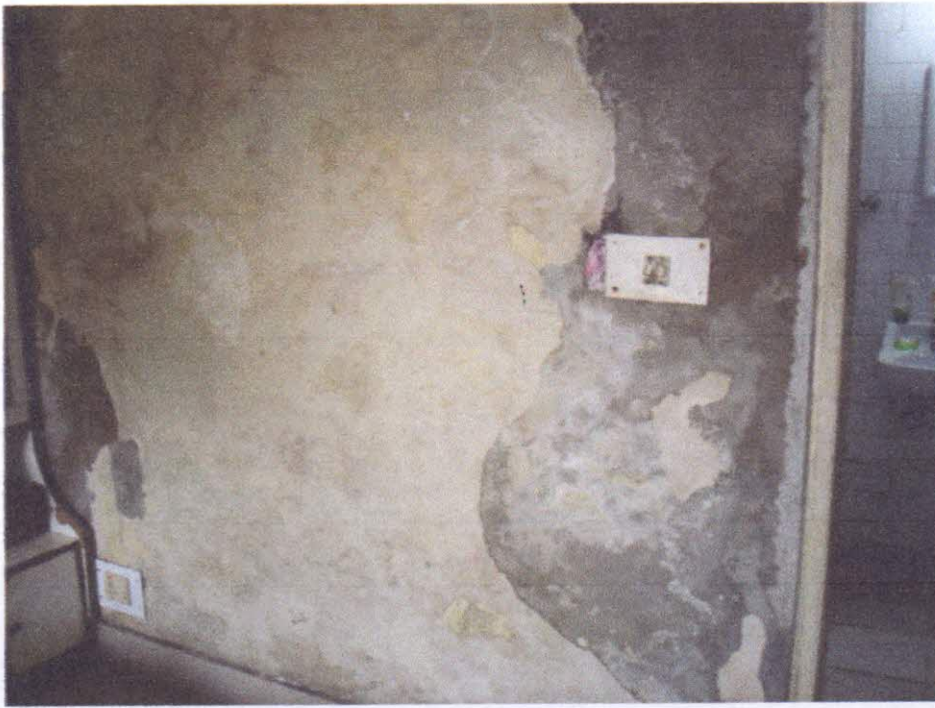
7

The wall looks very untidy due to the patches and stains caused by the loss of plaster and dampness. Electrical conduiting has also turned vulnerable due to this.

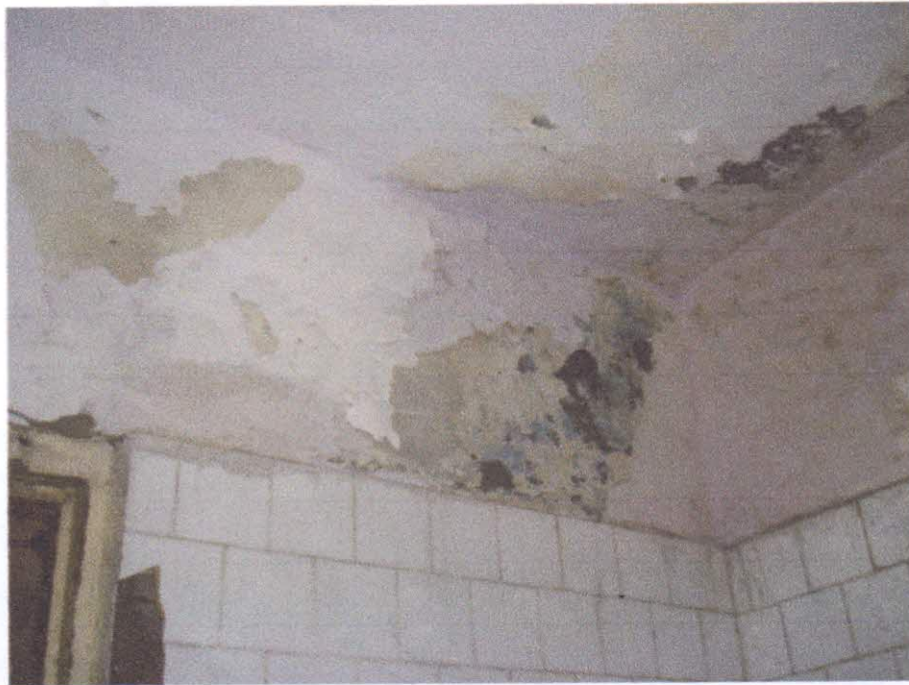
8

Chipped off plaster in the toilet.

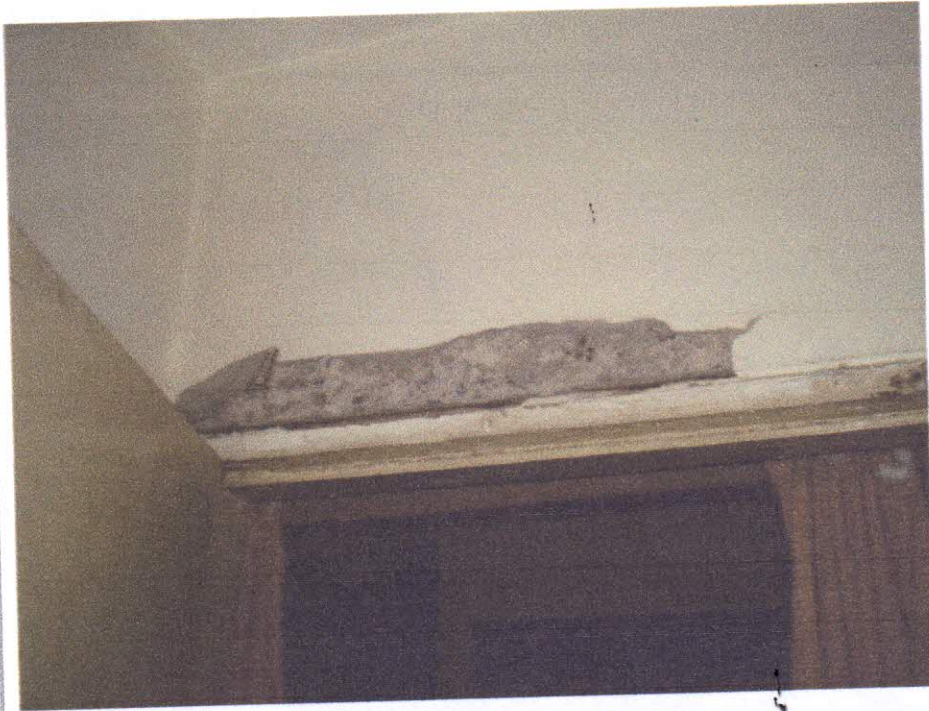
9

Untidy patches caused by the falling off plaster in patches. Here it can be seen over the door.

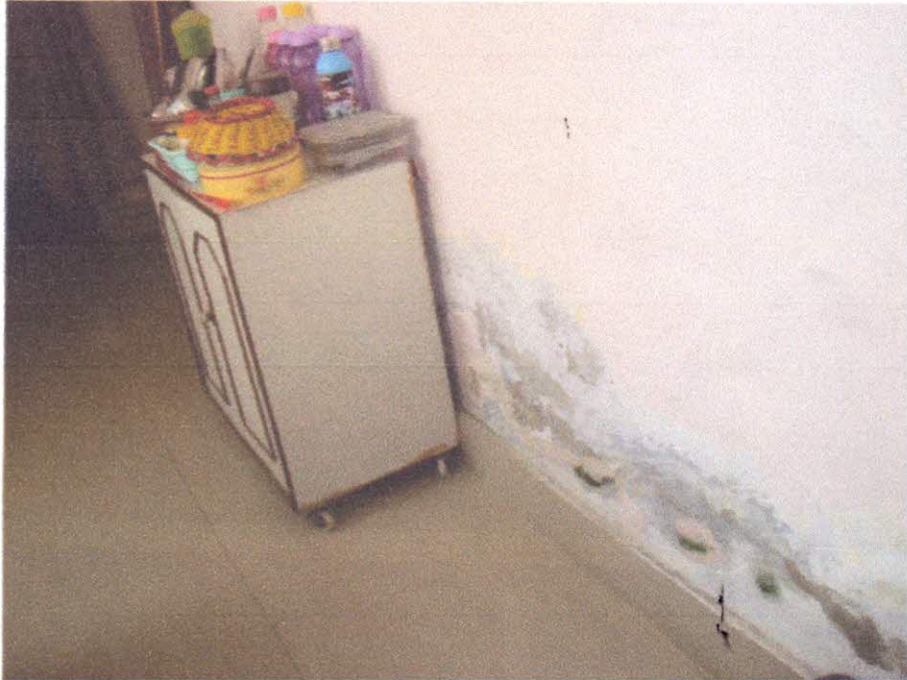
The chipping off plaster and paint from the wall surface in the lobby of the flat.
2

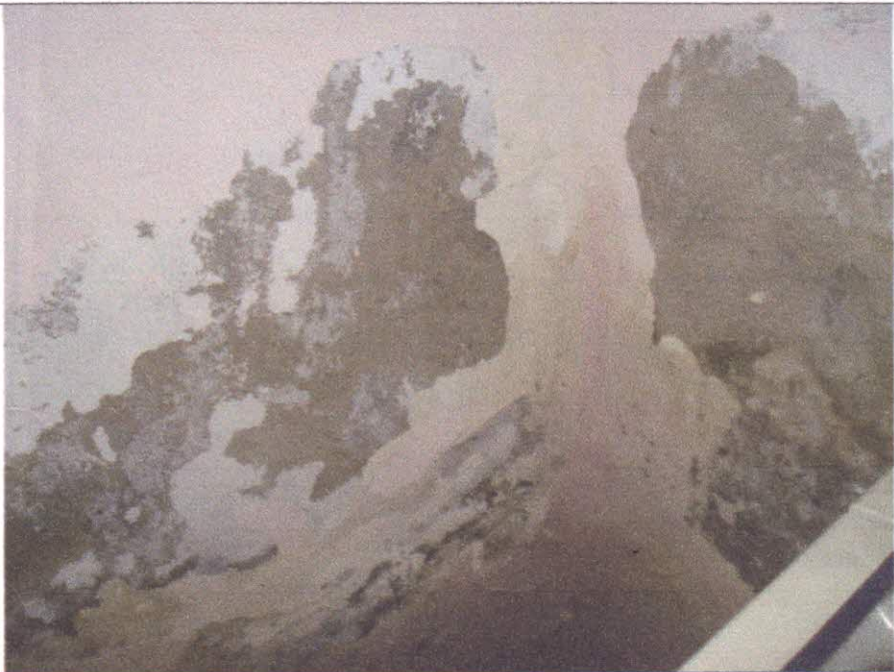
Seepage in the wall and the consequent chipping off surface finish

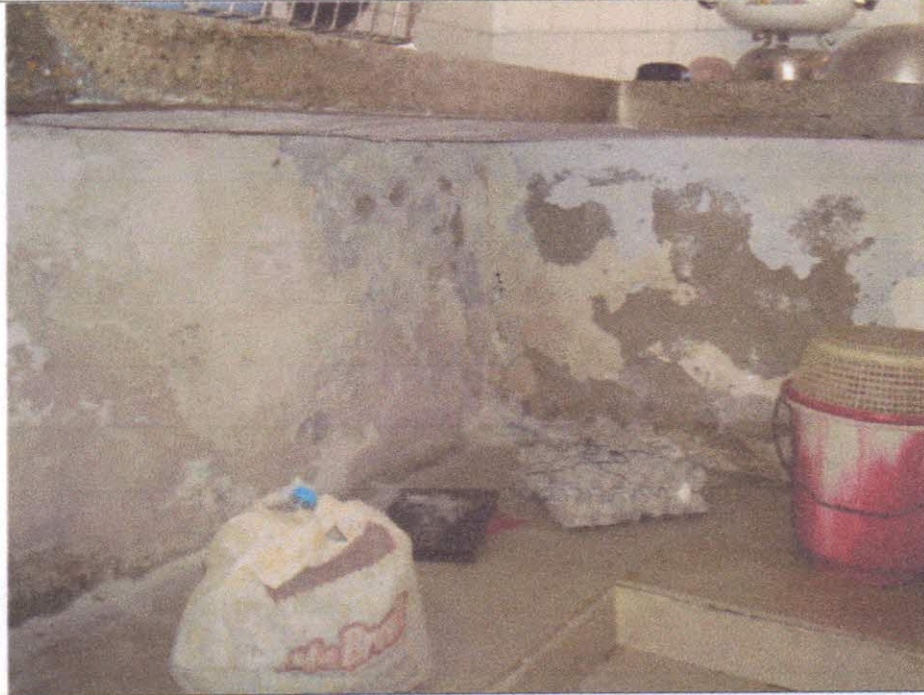
3

Damaged wall surface due to chipped off plaster in the kitchen
shelf area

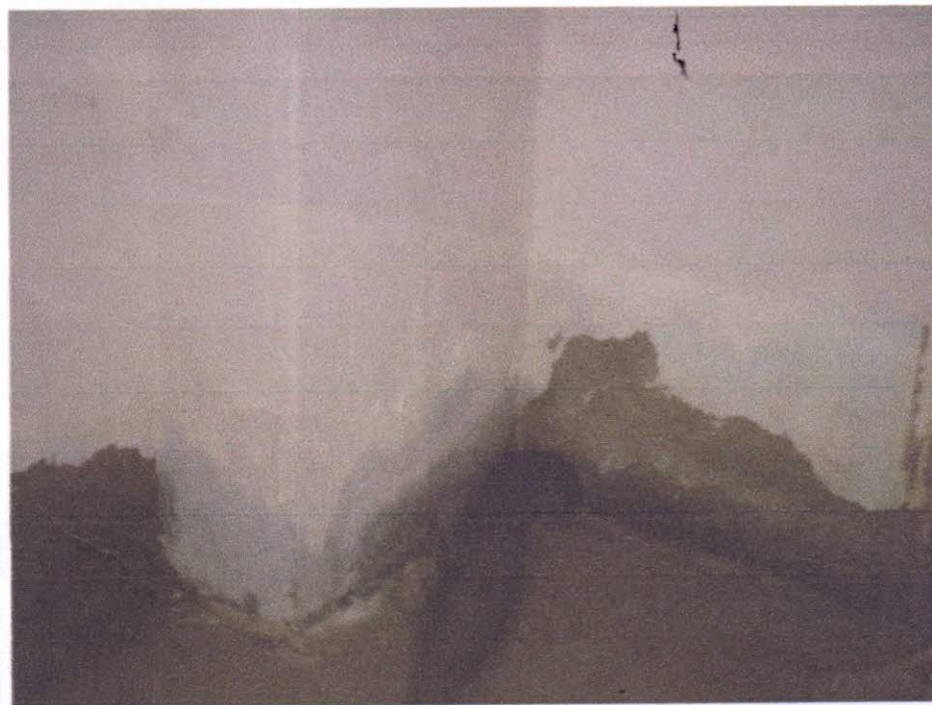
4

Continuous patches have formed on the periphery of the wall surface. Kitchen is the worst affected part.

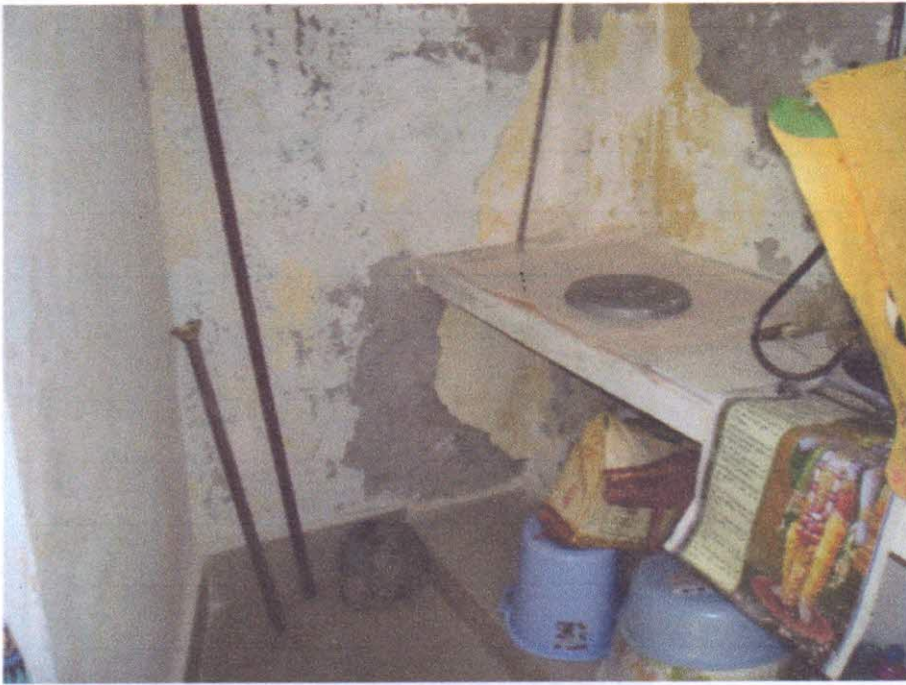
Loss of plaster due to the seepage in the inner bedroom shelf area

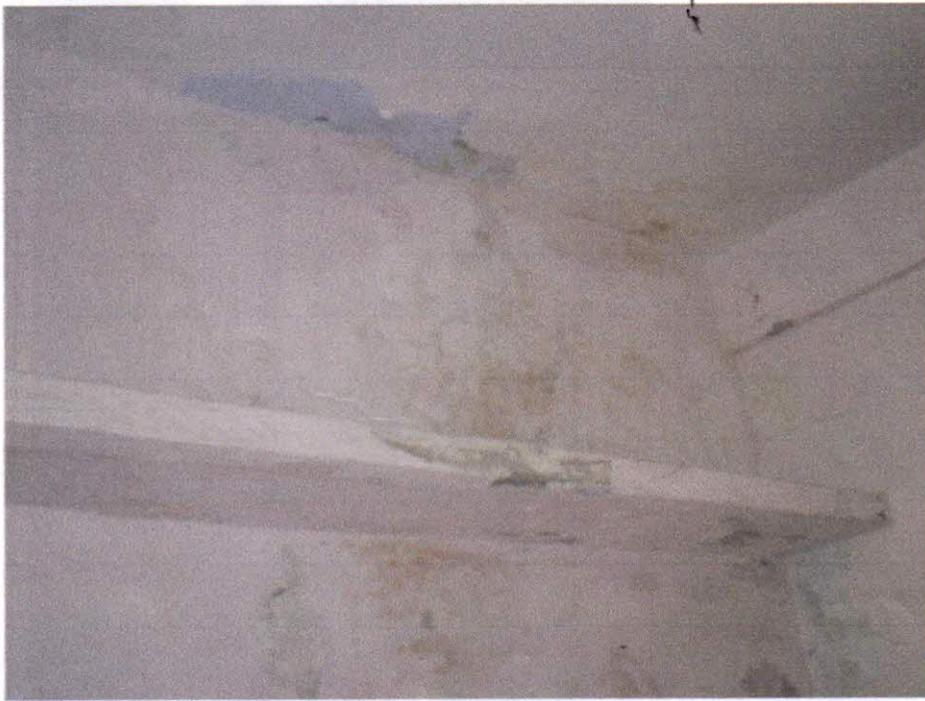
5

Stained surface of the wall due to the moisture content in the wall.

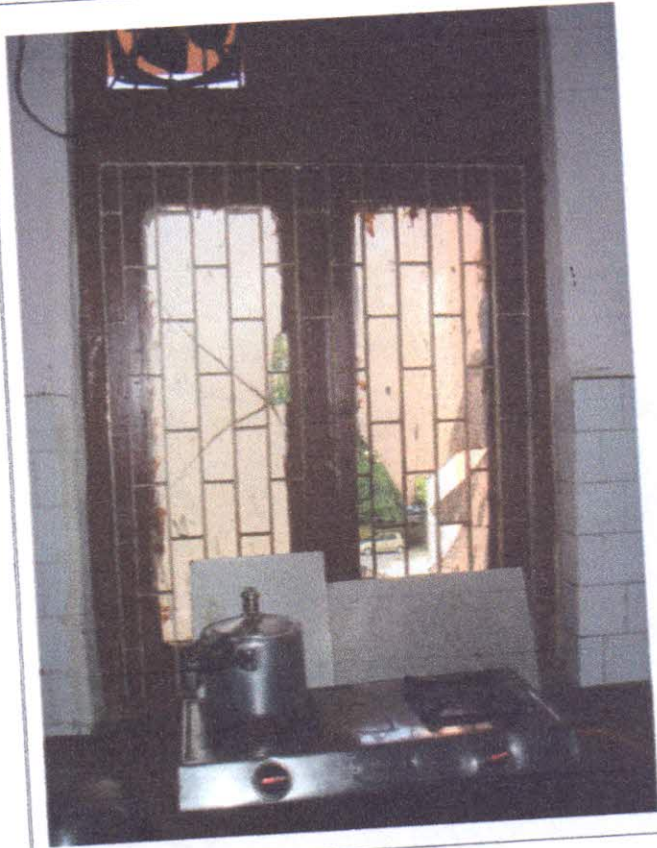
6.

Broken
window panes
of the kitchen
window

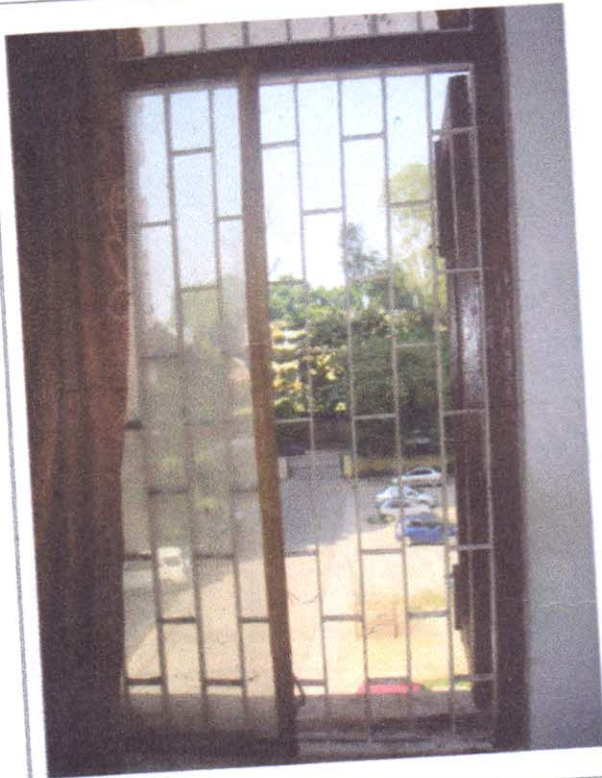
7

Broken
window pane
in the drawing
room window.

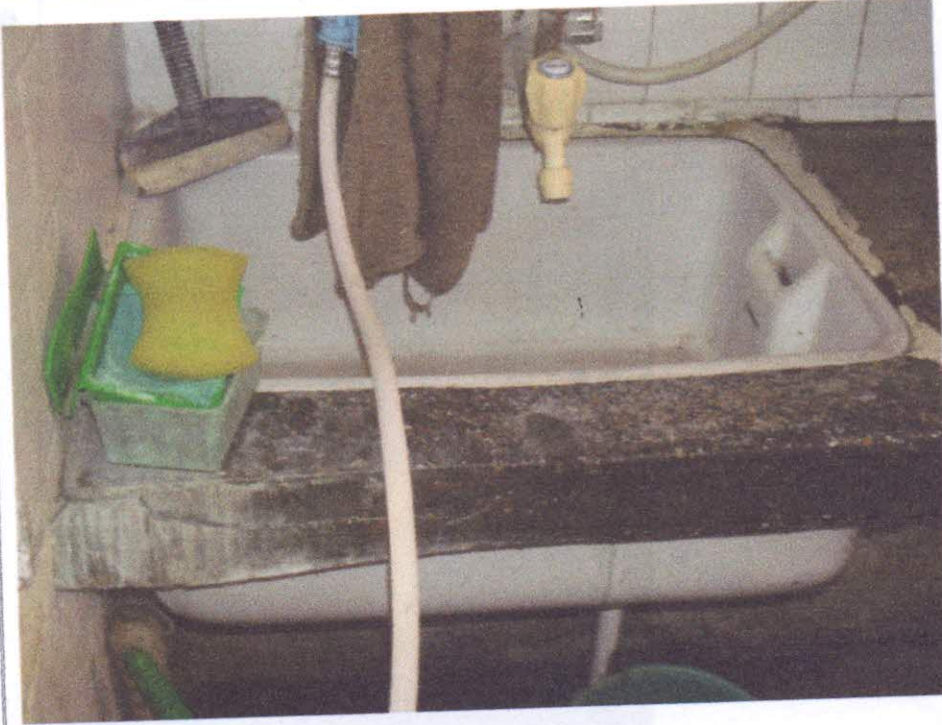
8

Cracked and broken parts of the kitchen slab also needs repair

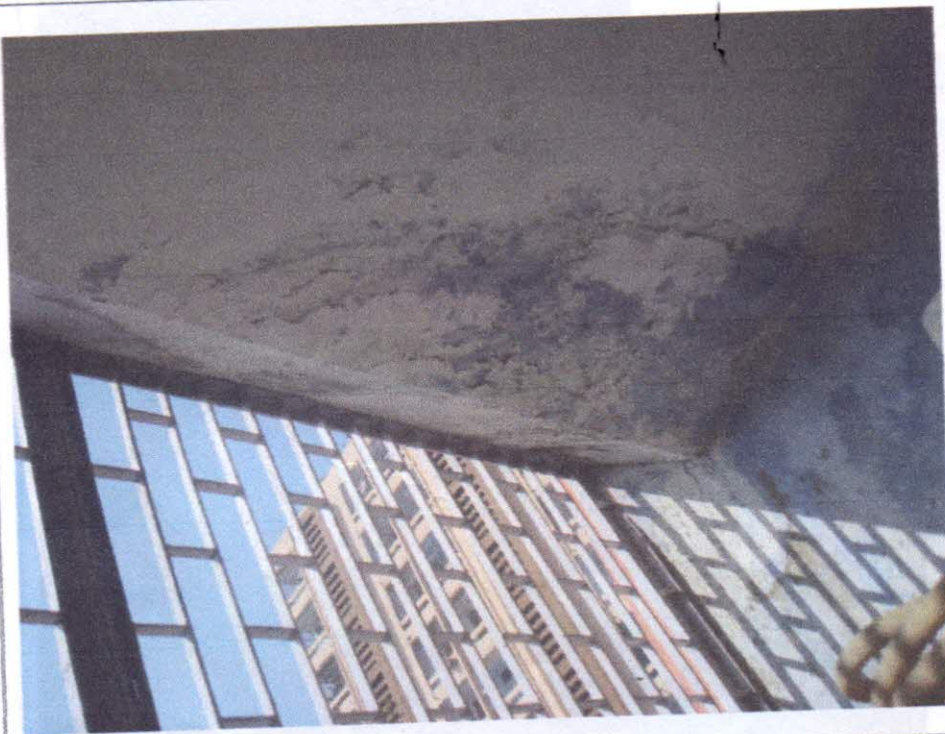
9

The slab of the balcony infested with seepage and damp surfaces caused by trickling of rainwater. There is no lining on the edge to avoid the trickling of water.

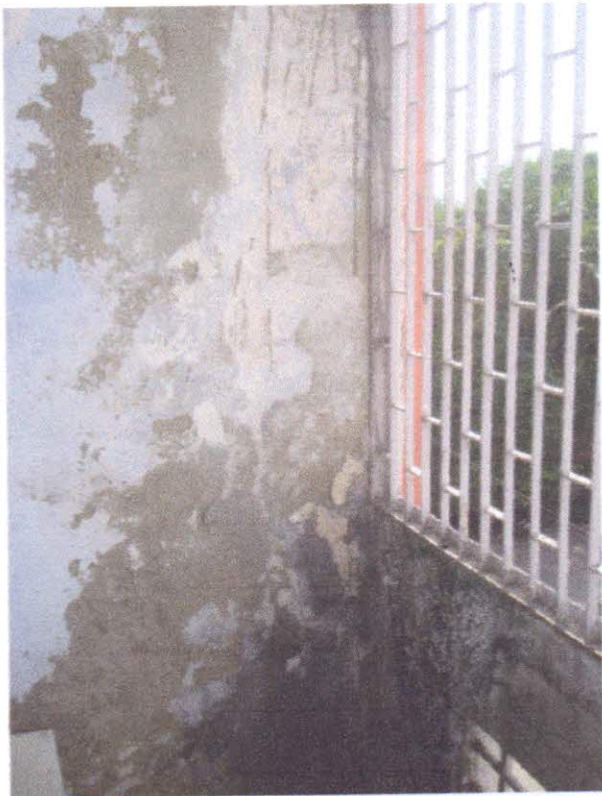
10

The damaged surface of the balcony wall due to the accumulation of the dampness.

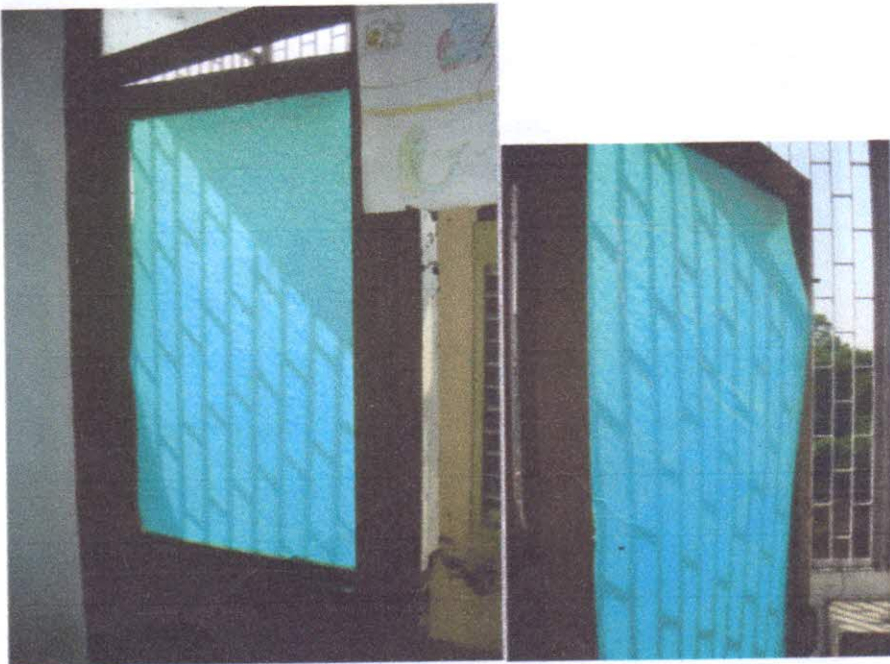
11

Broken panel in the balcony door needs repair

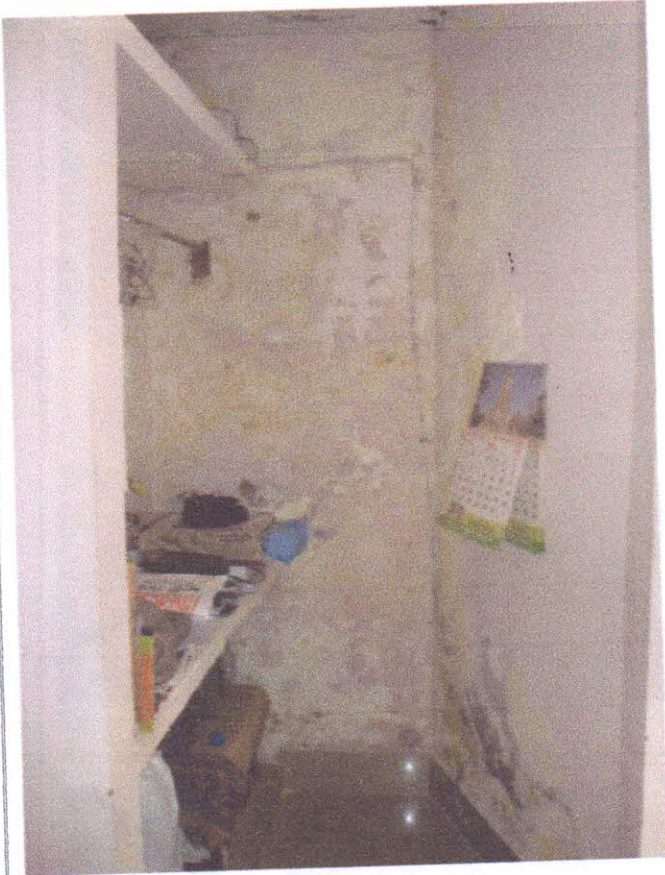
12

Stained and patched surfaces of the shelf wall in the rear room connecting the balcony.

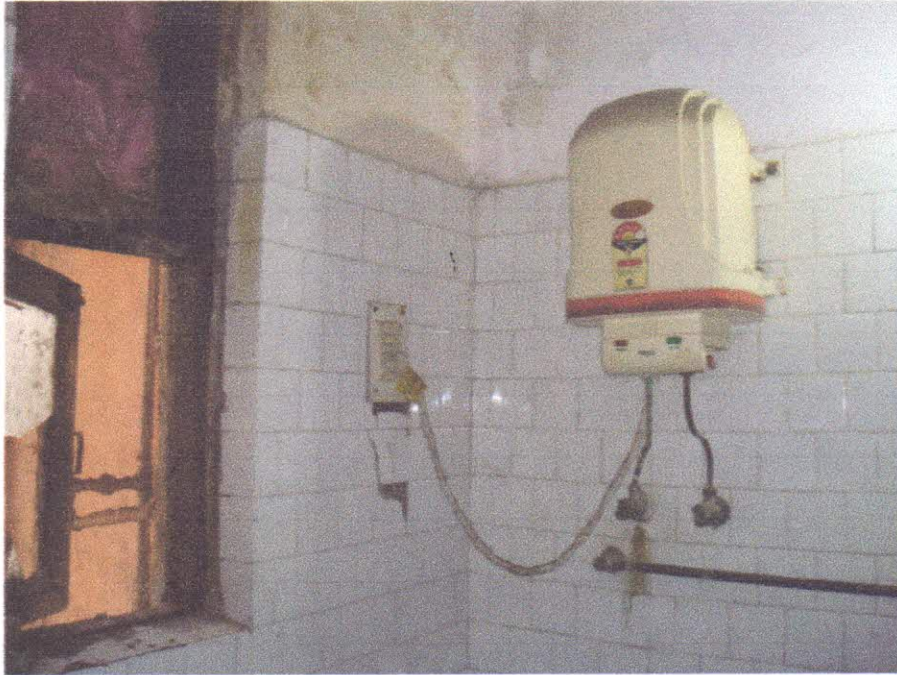
13

Broken tiles of the bathroom need to be replaced

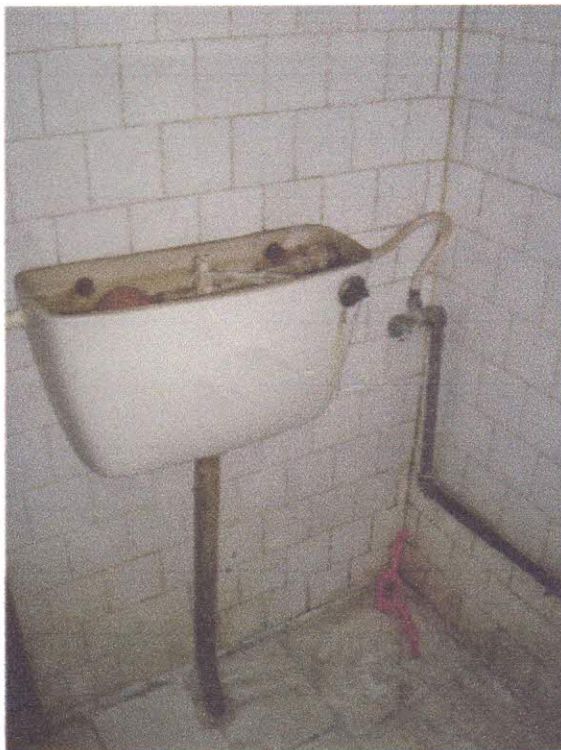
13

Dysfunctional cistern in the bathroom

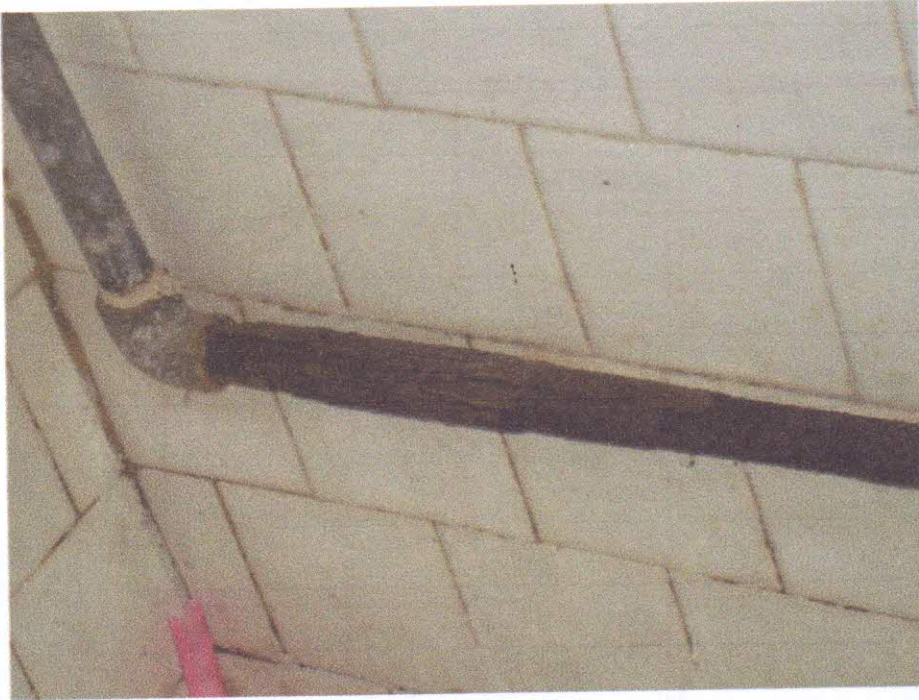
14

Rusted pipelines need to be replaced in the toilet.

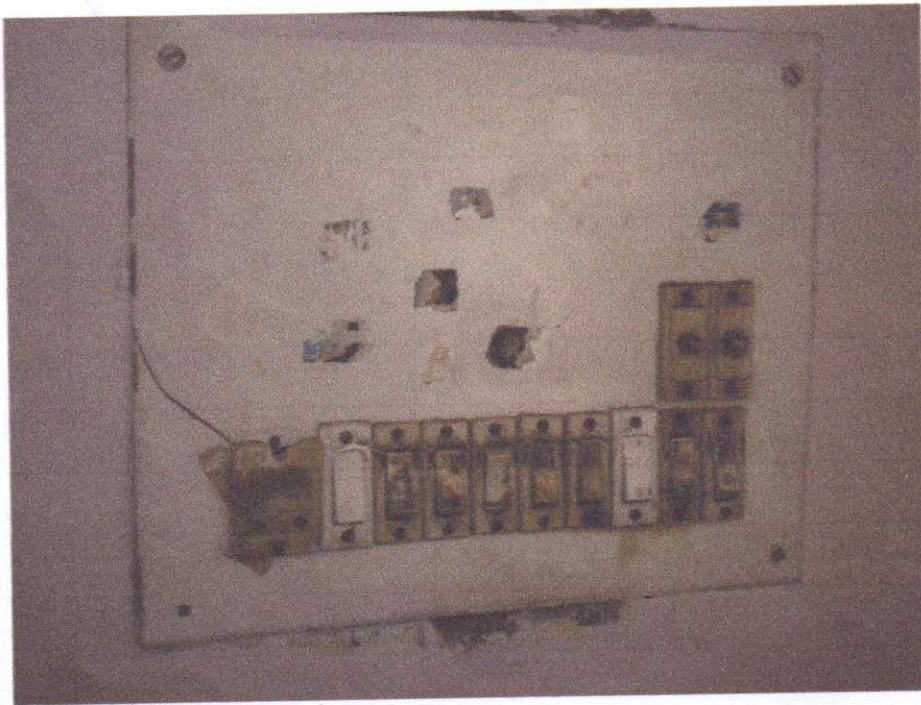
15

Switches and the board itself are also cracked and need to be replaced.
